MERRIMACK RIVER BASIN
STODDARD, NEW HAMPSHIRE

HIGHLAND LAKE SOUTH OUTLET

NH 00054

PHASE I INSPECTION REPORT
NATIONAL DAM INSPECTION PROGRAM

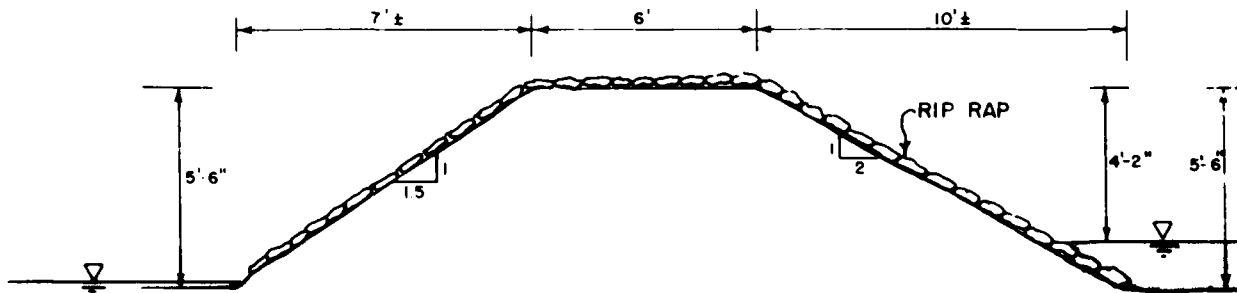
FIG. 4

Inspection of the impounded shoreline revealed the existence of a 57 foot long, 5.5 foot high earth and rock dike approximately 150 feet west of the right abutment (Figure 4, Photo 1). Investigations indicated that local residents built this dike in the late 1930's to prevent inundation of land developed after the construction of the dam, but which flooded at lake levels well within the design capacity of the South Outlet. This structure is discussed in greater detail in Section 3.

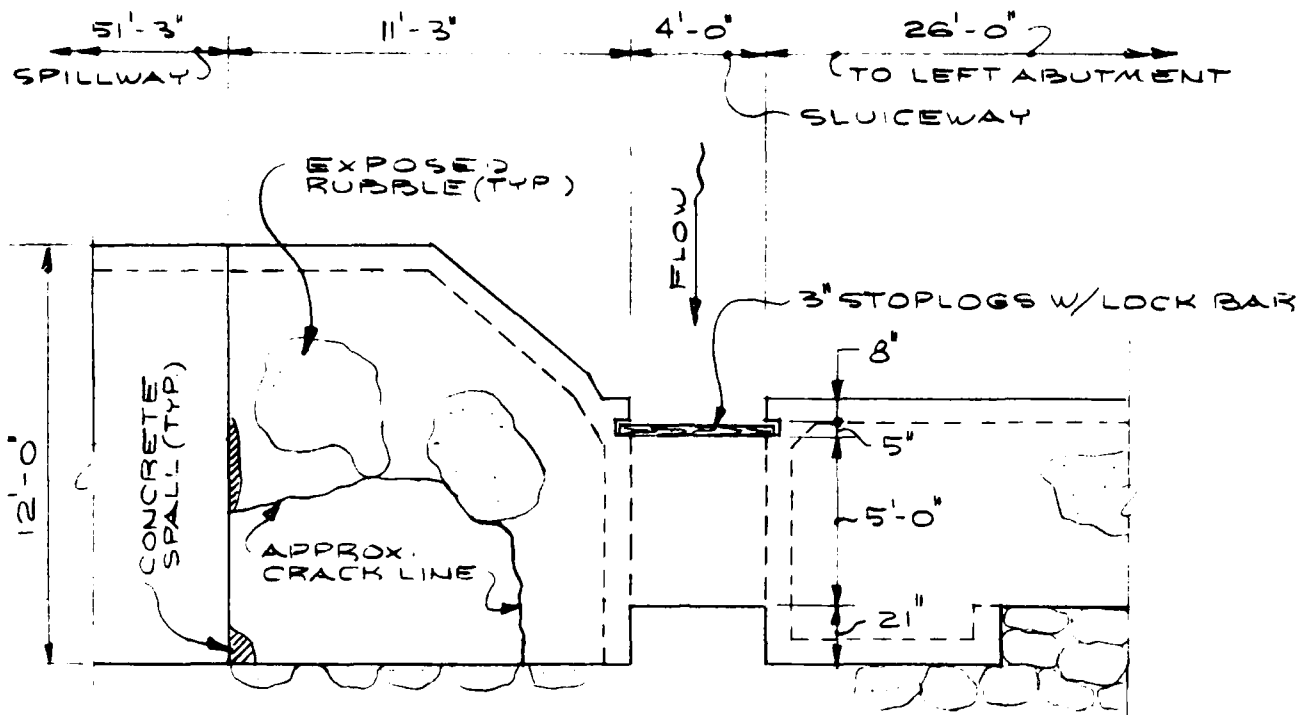
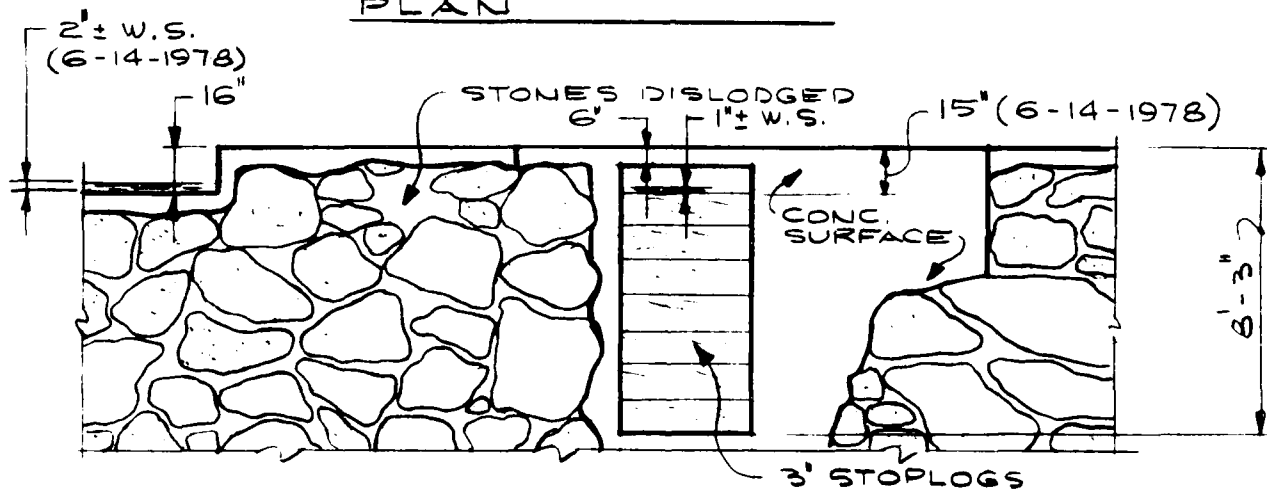
FIG. 3

The dam includes a 4 foot wide sluiceway with stop-logs near the left abutment (Figure 2). Approximately 7 feet of stop-logs were in place at the time of the inspection. The stop-logs require manual removal and a bar lock secures them in the dam. The invert of the sluiceway is at Elevation 1289+.

SLUICWAY DETAIL
